West Seattle Rotary Viewpoint 35th SW and SW Alaska

West Seattle Rotary Viewpoint

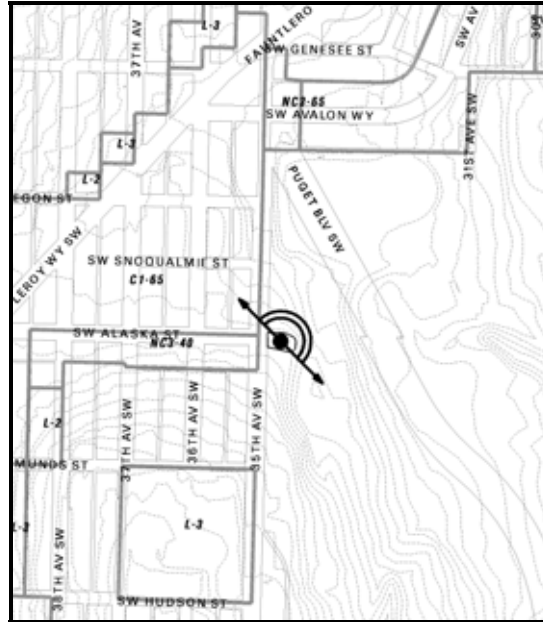
The park is located in the Delridge neighborhood in West Seattle. The viewpoint provides panoramic views of the Cascade Mountains and wide-angle views of the downtown skyline. The viewpoint is located within the West Seattle Recreation Areas, the site is managed by DPR and overlooks the West Seattle Golf Course. Approximately 50% of the intended view is unobstructed.

Himalayan Blackberries dominate the hillside. They have recently been cut back exposing an eroded slope along the top of the hillside. Extended views are obstructed by a row of Poplars growing along the edge of the Golf Course parking lot.

1. Tree removal and/or pruning using ANSI 300 standards of poplars
2. Remove invasive weeds at the crest of the slope
3. Protect slope with erosion control matting
4. Plant a double row of low hedges along Transition Zone 2
5. Mulch eroded areas
6. Establishment watering

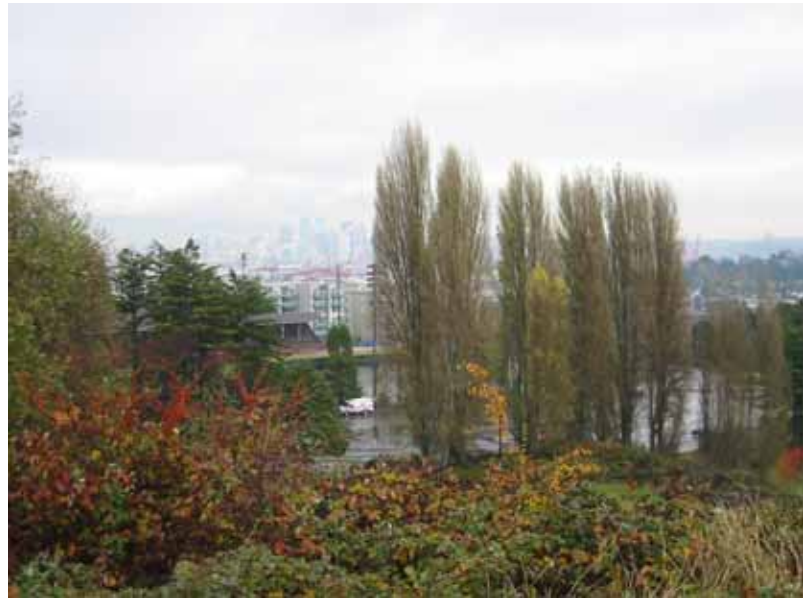
Poplar trees
obstructing views of
downtown Seattle

- Phase 1 - Prune and/or remove poplars
- Phase 2 - Eradicate invasive weeds at top of slope
Cover slopes with erosion control mat
- Phase 3 - Plant Zone 2 transition hedge at top of slope
Provide temporary irrigation

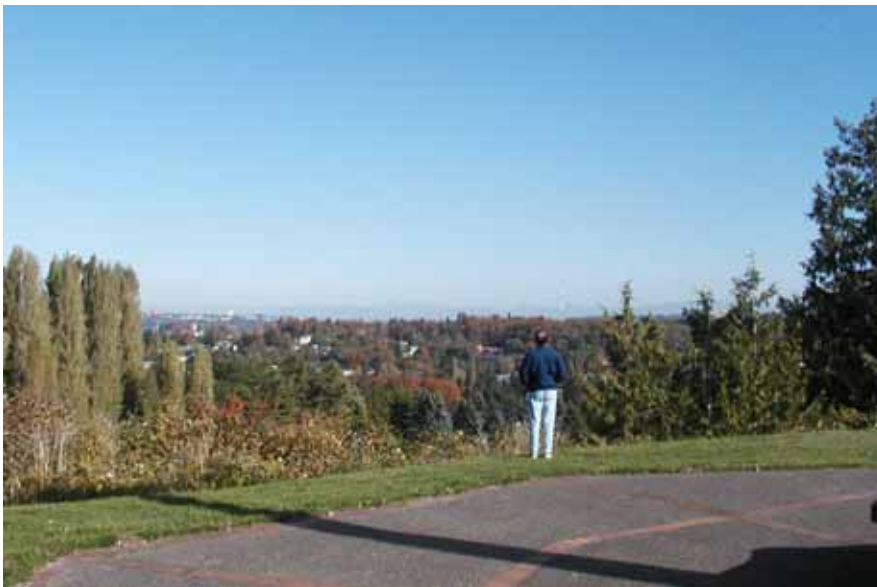
View to east,
transition
planting
needed at
crest of slope

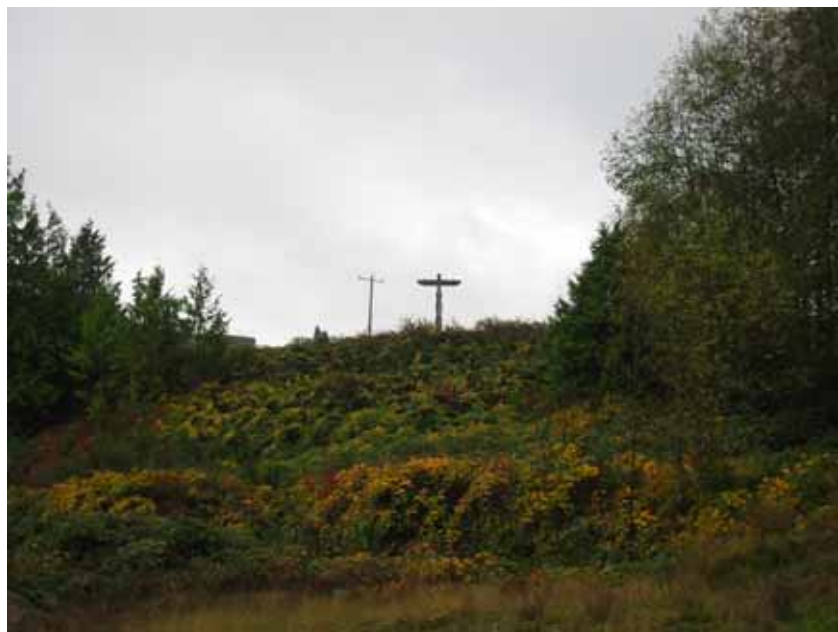
Park hillside below
viewpoint

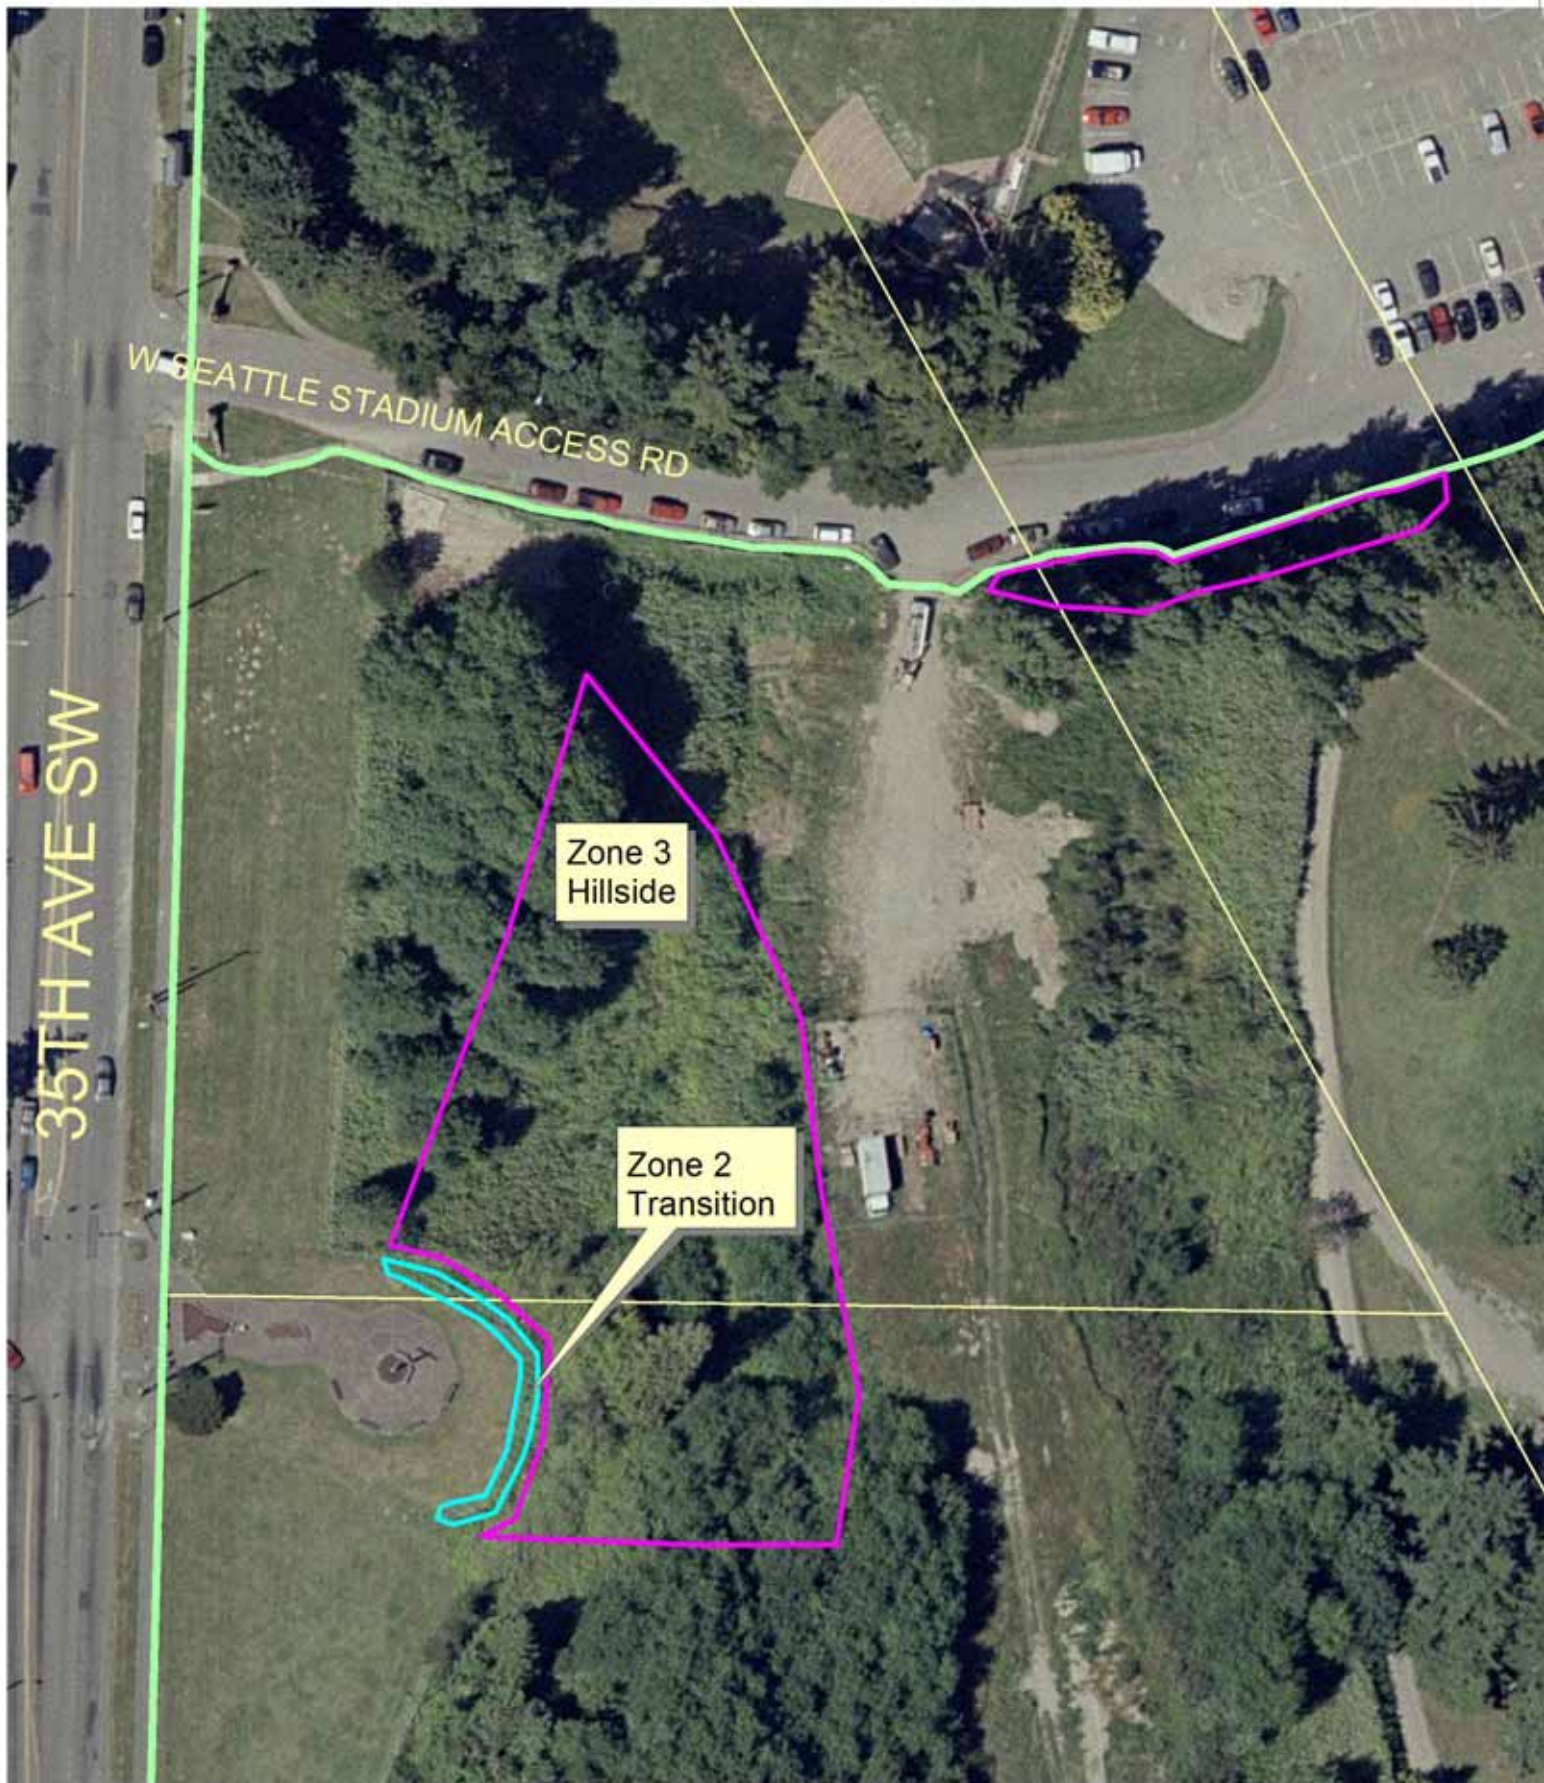
West Seattle Rotary Viewpoint

View management locations:
Zone 2 - Transition area at the crest of the slope
Zone 3 - Hillside
